# INSTALLATION OF BLIND

MAIN MECHANICAL CONTRACTOR  
FOR CHEMICAL PLANT

FREEPORT, TX, USA

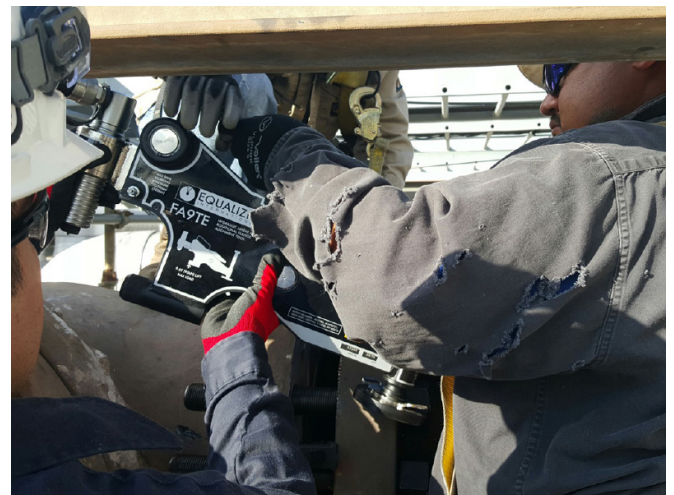
The contractor began to de-torque and remove the bolts the day before maintenance was scheduled. They had only removed one quarter when the flange began to misalign and this resulted in the remaining bolts binding and seizing in the boltholes. Consequently, the operators spent 23 hours attempting to cut the jammed bolts in order to pull them out. This was a slow, unsuccessful and costly process.

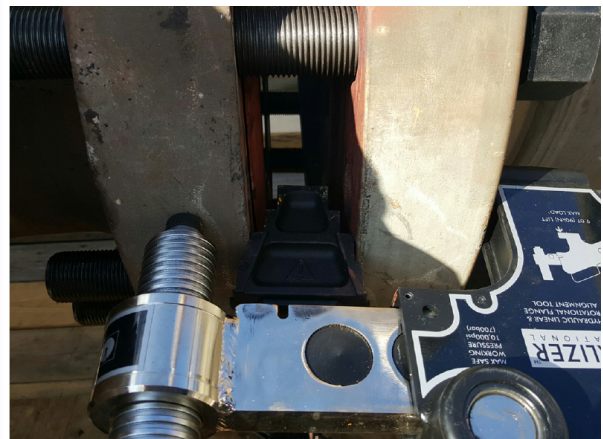
The FA9TE alignment tool was attached at the 12 o'clock position on one flange to lift the opposite flange and bring the joint back into alignment. The alignment tool was set and levelled on the flange and then the pump and hose were connected. Set up and alignment took no more than 5 minutes. The seized bolts were removed and new bolts were inserted on the lower part of the flange (4-8 o'clock), leaving access to lower in the 18" blind.

In order to create the gap to install the blind, two SWi1214TM Mechanical Spreading Wedges were inserted on each side (3-9 o'clock). Once a sufficient gap was achieved, safety blocks were inserted and both the SWi1214TM Mechanical Spreading Wedges and the FA9TE Hydraulic Fixed Flange and Rotational Alignment Tool were removed. The blind was lowered into the correct position with no difficulty and all remaining bolts were installed.

The job was completed safely and successfully in 40 minutes with no issues.
